Test Report

Report No. A2200397792101002b

Sample Name SMA Jack Nautilus SS with Silicone O-Ring to I-Pex MHF

Type CAB412RF-0050-1-S

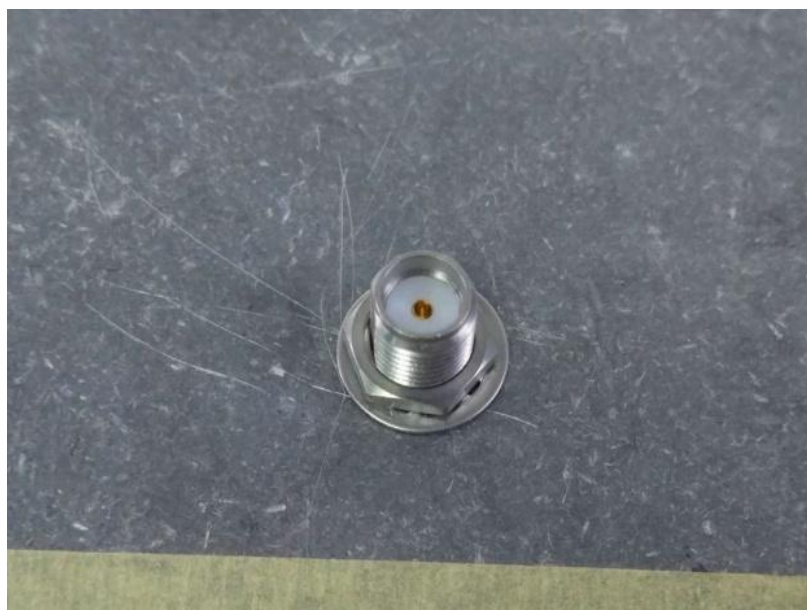
Sample No.	Sample Name	Type
A2200397792101002	SMA Jack Nautilus SS with Silicone O-Ring to I-Pex MHF	CAB412RF-0050-1-S

Sample Photo(s)

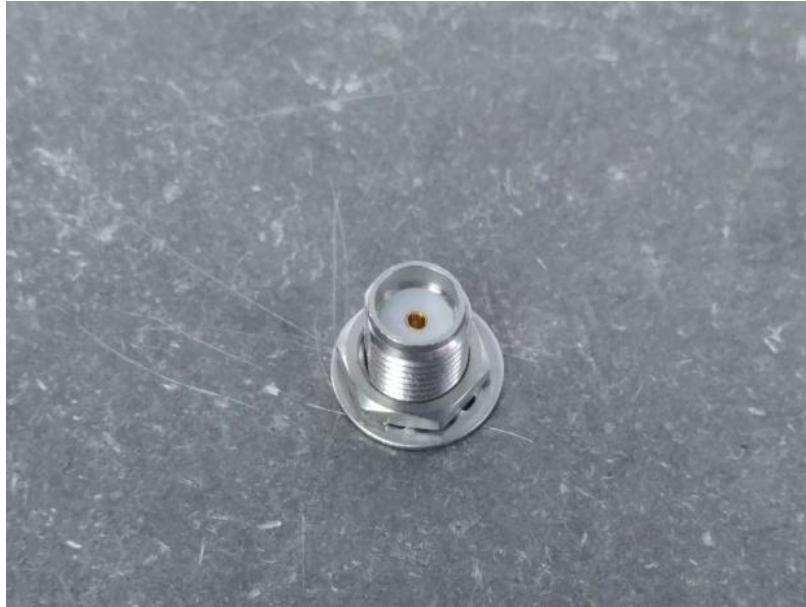
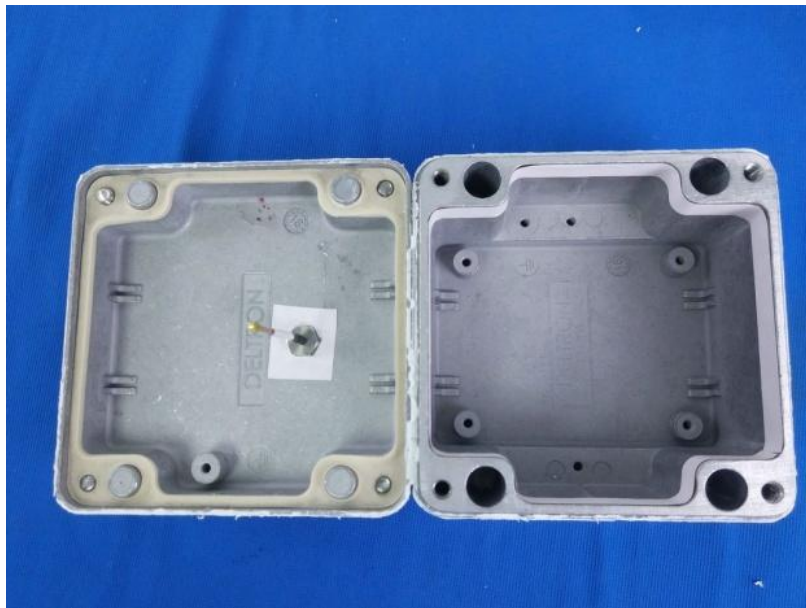
Sample No.	Result(Visual inspection)	Conclusion
A2200397792101002	No water was observed in the sample by visual inspection after test.	PASS

Sample Photo(s) after the test
