**Tests on a range of coaxial bulkhead connectors
on behalf of GradConn Limited**

Report No: N70049433B
Commercially in Confidence

TEST REPORT

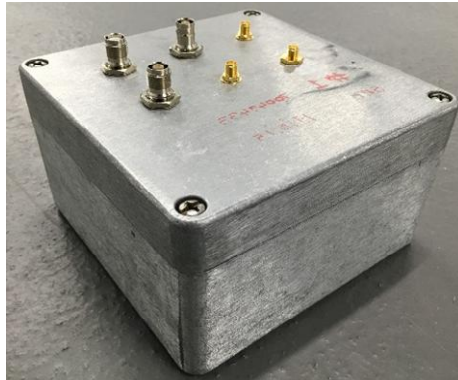
Figure 1 – Supplied enclosure with coaxial bulkhead connectors fitted

The dimensions of the enclosure were, 155 x 155 x 85 (L x W x H)

The connectors were fitted with seals that compressed against the inside wall of the enclosure.

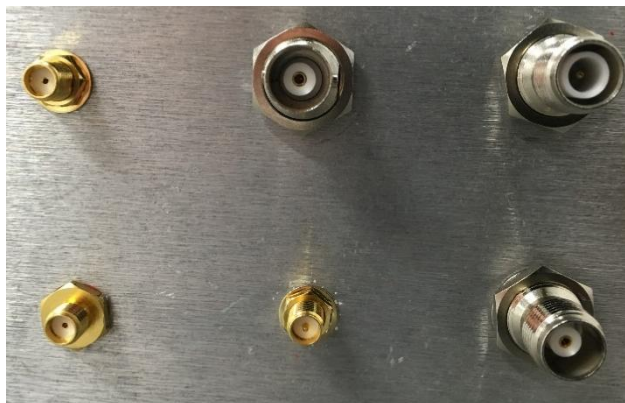
Figure 2 – Showing coaxial bulkhead connectors

The connectors were tightened to torques specified by the customer. The SMA coupling nuts (gold) were tightened to 1.7 Nm and the *NC coupling nuts (silver) to 2.3 Nm.
