Sample Name SMA Straight Bulkhead Jack w/o-ring  
Model No. RFCT-SMA081  
Sample Receiving State Normal  
Sample Received Date Apr. 25, 2024  
Testing Period Apr. 25, 2024-May 6, 2024

No.	Test Item
1	IPX7

## Test Report

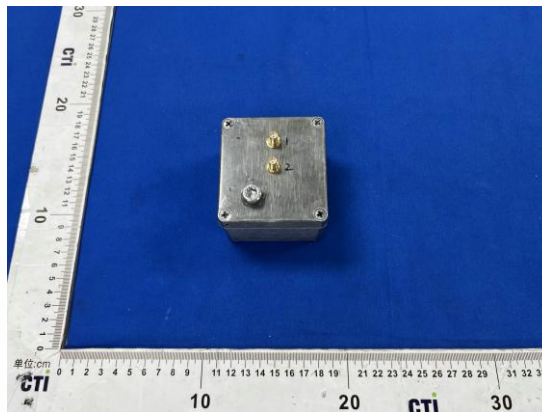
Sample No.	Sample Name	Type	Quantity
A2240232398101001	SMA Straight Bulkhead Jack w/o-ring	RFCT-SMA081	1pc

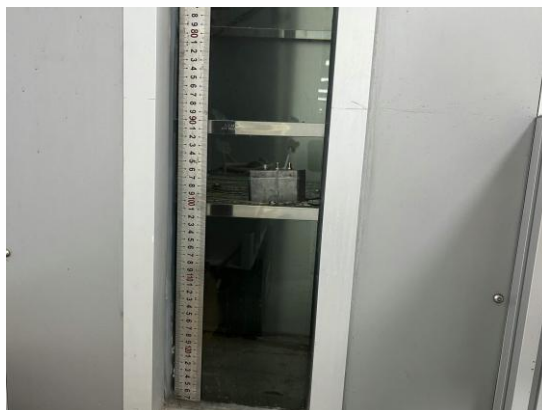
**Test Photo(s)**

The lowest point of the sample is located 1000 mm below the surface of the water.

Test duration: 30min

Sample No.	Criterion	Test result (Visual inspection)	Conclusion
A2240232398101001	No water enters the sample	No water enters the sample	Pass
Remarks: The judgment basis is provided by the customer

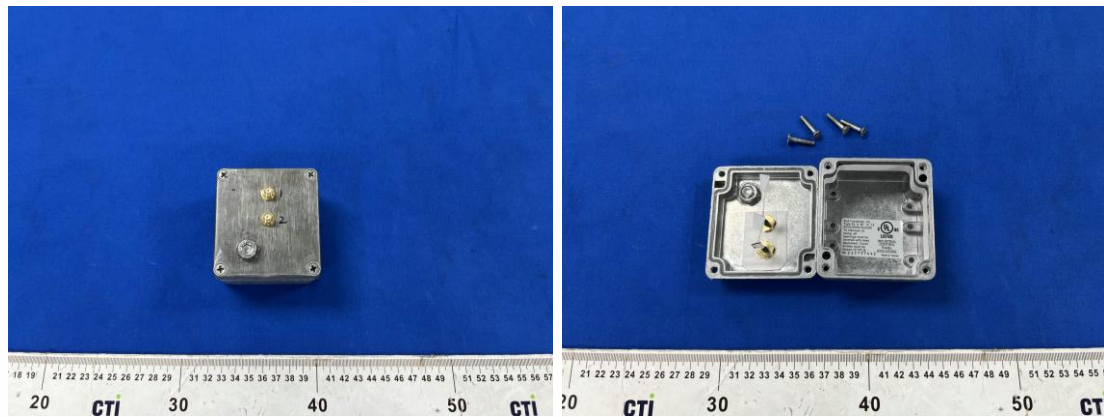
A2240232398101001

**Sample Photo(s) after the test**
